Study of the effect on manufacturing parameters on the fatigue behavior of aluminum engine mounting bracket

ARTICLE INFO	ABSTRACT
<p>Article history:</p> <p>Received : 8 Jun 2024</p> <p>Accepted: 27 Sep 2024</p> <p>Published: 21 Oct 2024</p> <p>Keywords:</p> <p>Engine mounting bracket</p> <p>Manufacturing parameters</p> <p>High cycle fatigue</p> <p>Fatigue crack propagation</p> <p>Strength improvement</p>	<p>The engine mounting bracket connects the engine to the car body and plays a key role in reducing vibrations and supporting the engine's weight and dynamic loads. It must be designed to withstand cyclic forces during normal use but fail safely in high-impact situations, like accidents, to minimize damage. This study examines how manufacturing parameters affect the fatigue performance of aluminum engine mounting brackets in cars. According to the staircase-Locati fatigue test results, the relative mean resistance load was measured at 1.24 with a relative scatter of 0.07, placing it in the unsafe operating region for the engine mounting bracket. To address this, a finite element analysis was carried out to identify critical areas on the part and implement modifications to enhance

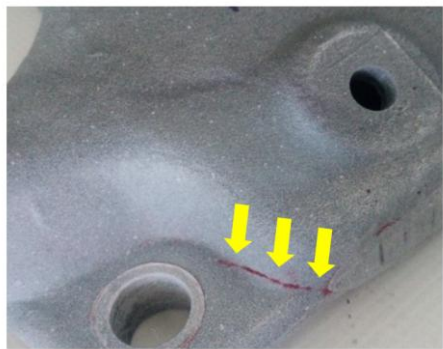
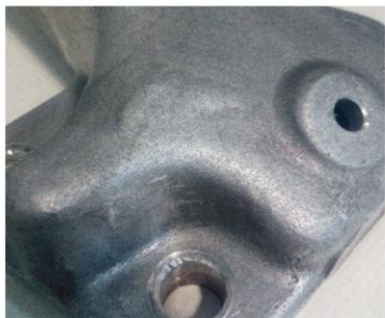
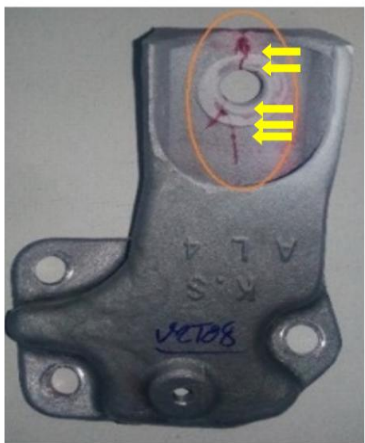
The reinforcement of the connection area of the base to the wall in the modified sample has led to the removal of the crack in this area. In order to make a more detailed investigation, after the completion of the fatigue test, a comparison of the primary and secondary samples was made by conducting a penetrating liquid test. Also, after fixing the manufacturing parameters to cause the cracks in the part, by repeating the high-cycle fatigue test on the modified sample, the crack moved from the connection area of the base to the wall to the end area of the part, as shown in Figure 11. This means that similar to the finite element results in the modified sample, the most critical region is located at point A. Table 9 shows the improvement of the modified sample respected to primary sample. As observed, the resistance of modified sample increased by 7% and scatter of fatigue results has decreased by 14%.

Figure 11. a) Identification of the crack in the front area of the primary sample. b) Removal of the crack in the front area of the modified sample. c) Appearance of a crack in the end area of the modified sample.
